TITLE	<b>GSA Private Lands Application for a Type A Land Use Permit</b>
SECTION	5: Borrow Sites
SUBJECT	10: Borrow Site 4.100P

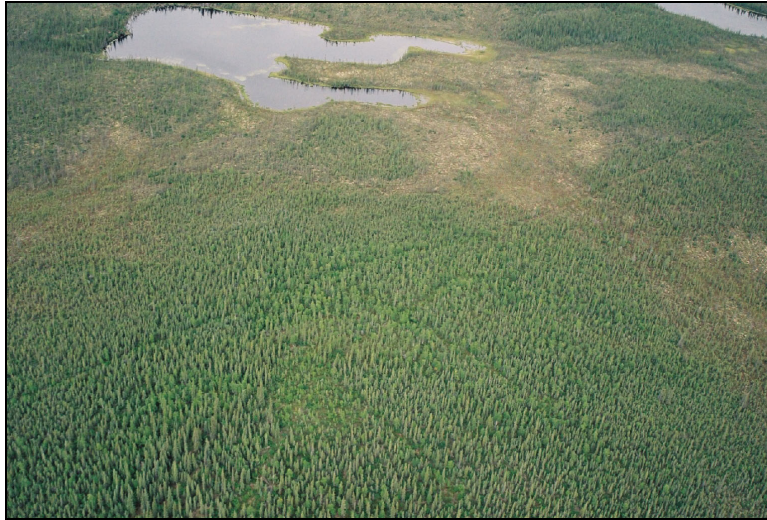
**Figure 5-42: Cutline Evidence of Previous Investigation on Borrow Source 4.100**

One borehole on the source was completed in 1973 (EBA 1973). Another seven boreholes were completed on the source in 1974 (PWC 1974). See [Figure 5-42](#). Of these, all of the boreholes lie within borrow site 4.100P. The following borehole information has been extracted from these previous studies.

The borehole completed by EBA penetrated about 1.2 m of clay underlain by about 7.9 m of shale. The shale was light brown-to-brown, soft to medium hard material with low moisture content.

The boreholes completed by Public Works Canada encountered peat and clay overburden thicknesses that ranged from 1.5 to 4.5 m. In all of the boreholes, soft to hard shale ranging in thickness from 3.0 to 10.7 m was encountered below the overburden. Material in the boreholes was frozen with low ice contents.

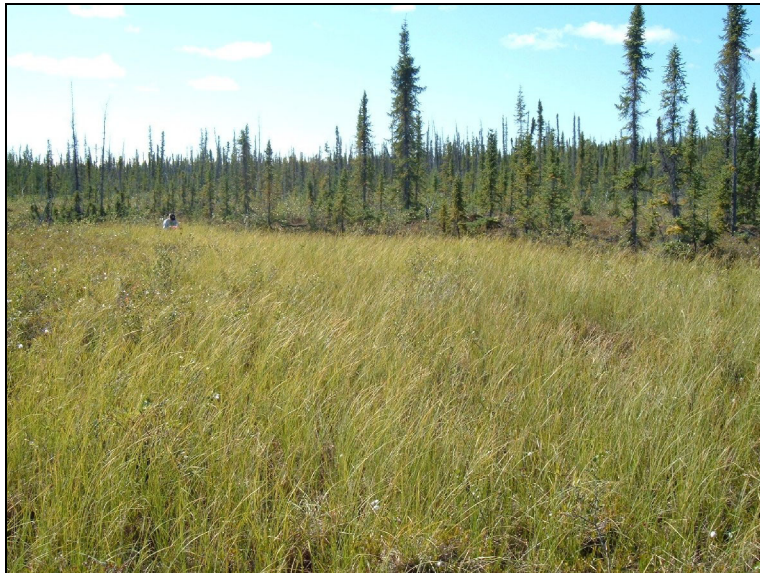
**Figure 5-43: Example of Vegetation at Borrow Site 4.100P**

This borrow site covers an area of both patterned graminoid wetland in the level, lower lying areas of the eastern half of the proposed site, and upland white spruce/Alaska birch on the mid to upper slopes, and crest of the hill in the western half of the site (see [Figure 5-43](#)). Both vegetation types were surveyed during rare plant and ecological land classification surveys in the summer of 2004. The access road will cross graminoid wetland, ground birch/water sedge wetland, upland white spruce/Alaska birch and black spruce/Labrador tea/mountain cranberry vegetation types.

The areas of forested vegetation are characterized by an open canopy of Alaska birch, and white and black spruce. The forest stand appears to be young with a
