## **Subsurface Information**

## **QUARRY DEVELOPMENT**

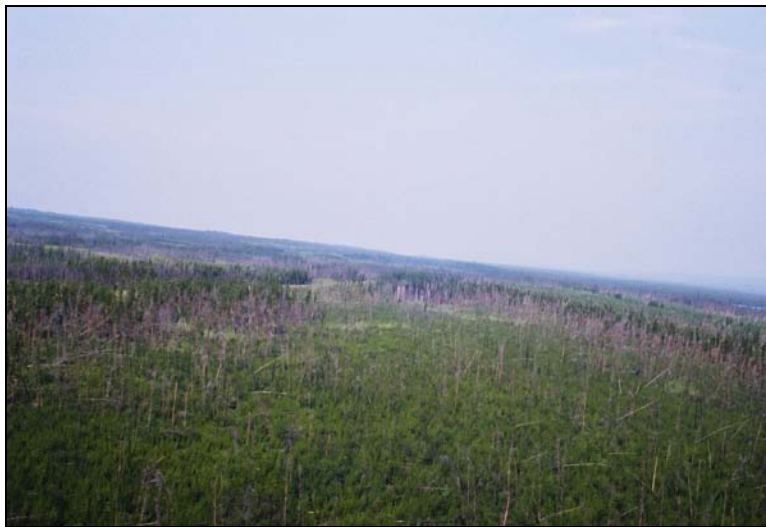
**Figure 5-64: Soils and Landforms Setting in Borrow Site 9.034PB**

Glaciofluvial sediments are well drained and have likely developed Orthic Eutric Brunisols. Previous geotechnical work suggests the surficial materials are mostly frozen. The ice contents in frozen areas are expected to be between 5 and 20%, by weight. [Figure 5-64](#) is a photograph of the soil and landforms setting at this borrow site.

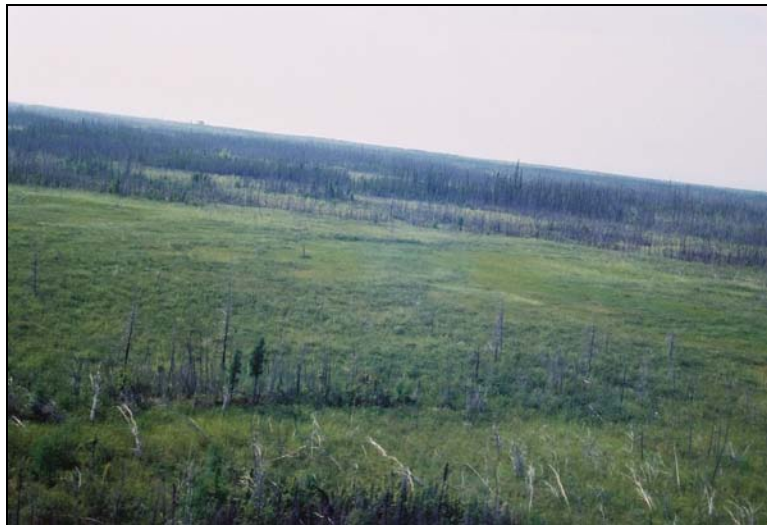
**Figure 5-67: Soils and Landforms Setting in Borrow Site 9.034PA**

Glaciofluvial sediments are well drained and have likely developed Orthic Eutric Brunisols. The land surface is flat to locally gently sloping. Previous geotechnical work suggests the surficial materials are unfrozen or frozen over between 5 and 10% of the landform. The ice contents in frozen areas are expected to be between 5 and 20%, by weight. [Figure 5-67](#) is a photograph of the soil and landforms setting at this borrow site.

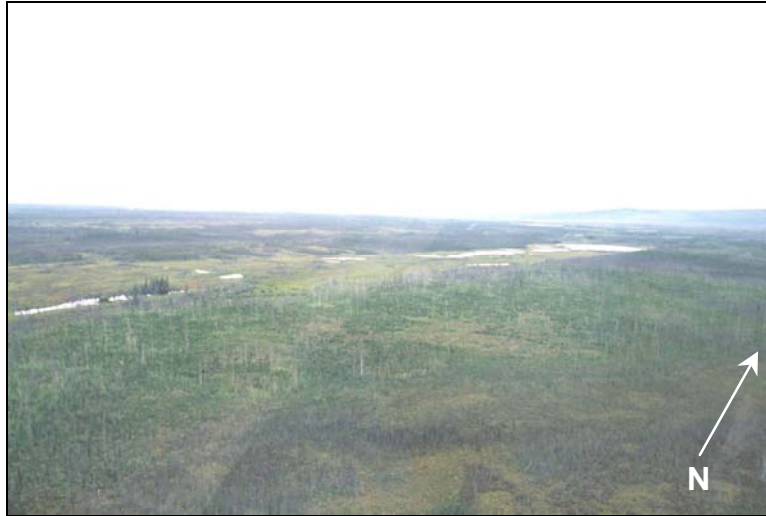
**Figure 5-71: Northern Part of Borrow Source 9.037**

Borrow site 9.037PA is located on the northern portion of a north-south trending glaciofluvial plain that is a broad, low feature rising about 5.0 to 6.0 m above the adjacent landscape, as shown in [Figure 5-71](#). The site is well drained and overburden consists of organic topsoil up to 0.3 m thick. Moderate to dense growths of spruce, poplar, and birch cover the site.

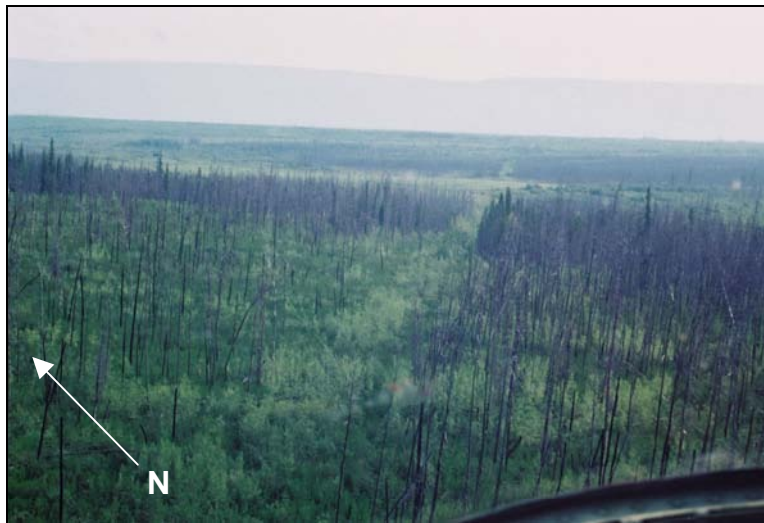
**Figure 5-75: Soils and Landforms Setting in Borrow Site 9.037PB**

Glaciofluvial sediments are well drained and have likely developed Orthic Eutric Brunisols. Previous geotechnical work suggests the surficial materials are frozen. The ice contents in frozen areas are expected to be between 5 and 20%, by weight. Fens form flat-laying plains that are very poorly-drained. Fen areas have likely developed soils of the Cryosolic or Organic Orders. Fen areas might not have areas of permafrost. [Figure 5-75](#) is a photograph of the soil and landforms setting at this borrow site.
