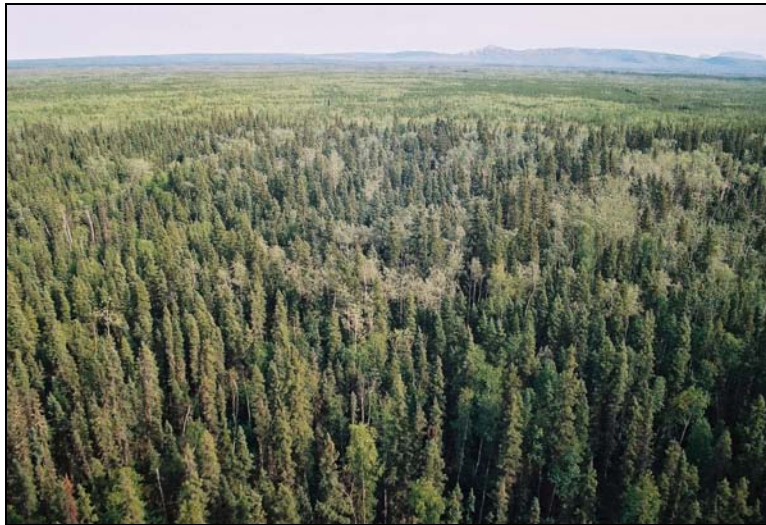
This borrow site lies within an extensive glaciolacustrine/deltaic plain that is composed of several terrain types. To the south, thin glaciofluvial sands overlie glaciolacustrine deposits. To the east of the borrow site, glaciofluvial sediments form a gently undulating plain. In the vicinity of the borrow site, glaciofluvial sediments form a hummocky terrain with kettle lakes. Wind action has locally shaped glaciolacustrine/deltaic sands into aeolian dune deposits.

The borrow site area is hummocky, and has gentle to moderate slopes, and is likely well to moderately well drained. Permafrost might be locally present in areas underlain with glaciolacustrine deposits (20 to 30% of area) or in hummocky terrain with kettle lakes (5 to 10% of area). Ice contents range from 30 to 100%, by weight, in deposits underlain with glaciolacustrine sediments and in the range of 5 to 20%, by weight, in kettled plain areas with poor drainage and mossy surface vegetation. The borrow site lies close to the pipeline right-of-way and will be accessed by roads crossing glaciofluvial sediments. [Figure 5-111](#) is a photograph of the soils and landforms setting at this borrow site.

**Figure 5-111: Soils and Landforms Setting in Borrow Site 20.086P**

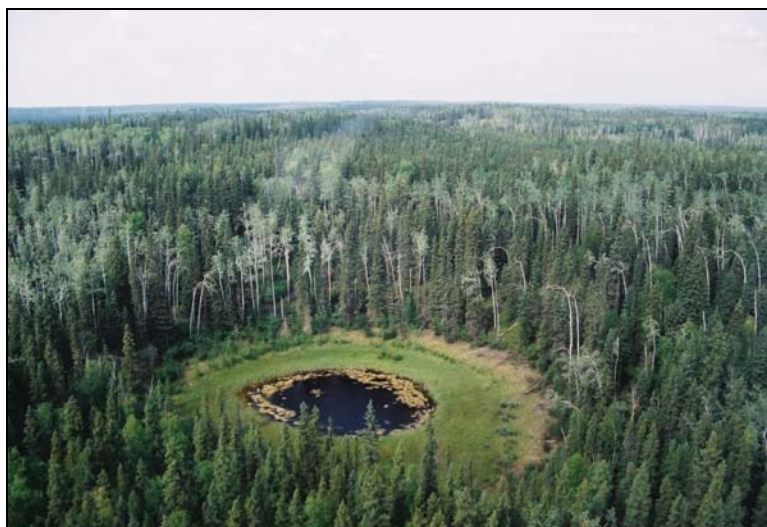
The predominant vegetation type of the proposed borrow site is mature upland white spruce – trembling aspen – jack pine. A small lake also occurs within the borrow site in the southwest corner. Surrounding the lake is a graminoid fen dominated by water sedge, hairy-fruited sedge and blue-joint reed grass vegetation types. Shrubs are sparse, but include long beaked willow and hoary willow. A vegetation survey and two rare plant surveys were conducted in 2004. No rare plants were observed.

The mixedwood vegetation type is located in upland forested areas, with jack pine, trembling aspen and white spruce in the tree canopy with white spruce in the sub canopy as well. Shrubs include green alder, prickly rose, soapberry, white spruce, trembling aspen and low-bush cranberry. Mountain cranberry, bunchberry, northern comandra, twinflower and fireweed compose the ground cover with stair-step moss and Schreber’s moss dominating the forest floor.

**Figure 5-112: Example of Vegetation at Borrow Site 20.086P**

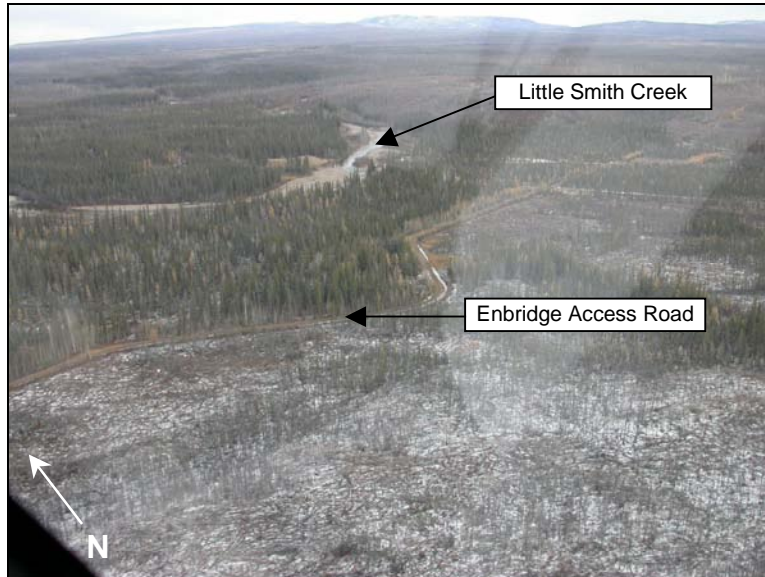
**Figure 5-115: Looking Northeast at Borrow Site 9.002PA**

Borrow site 9.002PA comprises the northern portion of a large glacial outwash plain that is broad and flat and rises about 3.0 m to 5.0 m above the surrounding terrain. The site is adjacent to the northeast bank of Little Smith Creek. The deposit appears to be well drained throughout. Overburden on the site typically consists of organic topsoil up to 0.2 m thick. The area has been repeatedly burned resulting in vegetation of low diversity.

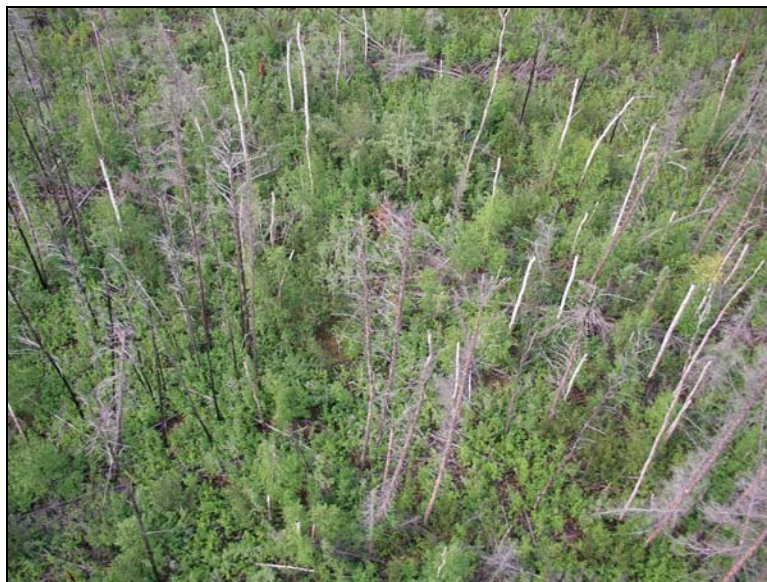
Vegetation of the borrow site is primarily burned black spruce – white spruce/stair-step moss vegetation with the lowland areas in the northwest corner of the borrow site being burned black spruce/Labrador tea/mountain cranberry vegetation type. Based on surveys of the area, the vegetation is characterized by numerous fire-killed snags, short (2 to 5 m in height) regenerating trembling aspen with jack pine and smaller amounts of white and black spruce, and by dense shrub cover. There are some areas of mature forest of both vegetation types throughout the borrow site in areas of unburned fire-skips. A vegetation survey for the borrow site was conducted.

Regenerating black spruce/Labrador tea/mountain cranberry vegetation is found in burned lowland areas with level topography. Black spruce is found in both the tree and the shrub layer. Labrador tea, willow, sweet gale, green alder and bog bilberry comprise the shrub layer along with Alaska birch, shrubby cinquefoil and prickly rose. The ground cover layer includes red bearberry and fireweed with an abundance of club lichens, pelt lichens and reindeer lichens.

**Figure 5-116: Example of Vegetation at Borrow Site 9.002PA**

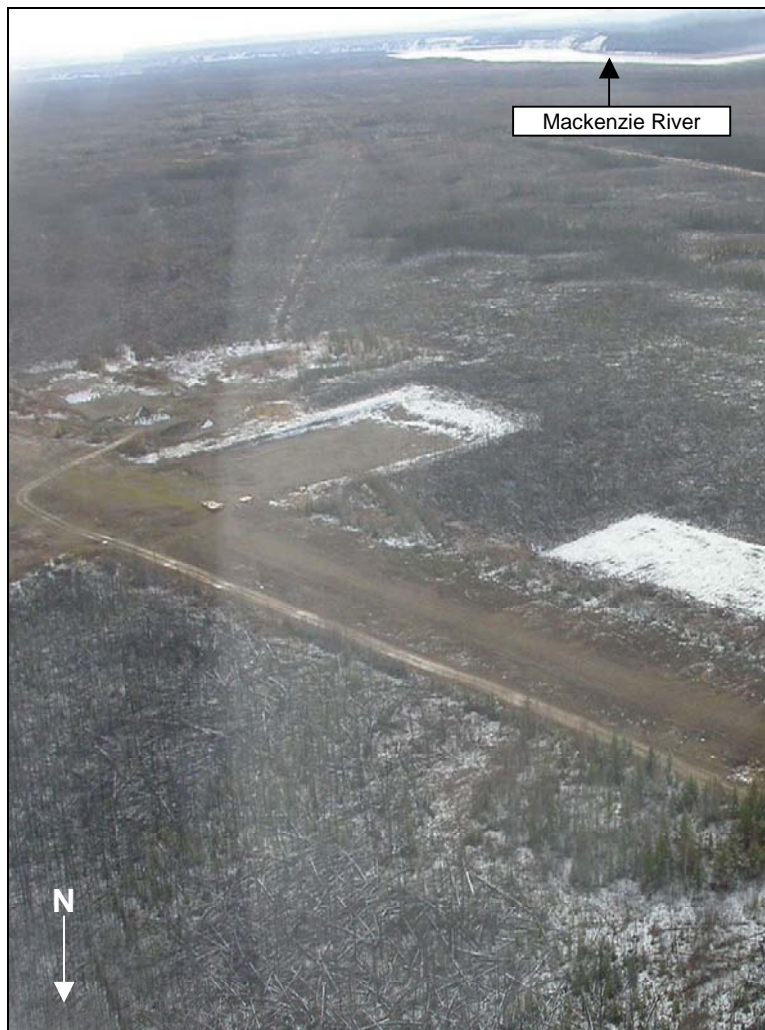
The majority of the southwest area of the borrow source, west of the airstrip, has been developed, as shown in [Figure 5-119](#). Although material in the pit seems similar, there has been very sporadic development. Up to 5.0 m of material has been excavated in the area of the pit, and it is estimated that 50% of the material is remaining. Once the available material in borrow site 9.002PB has been exhausted, borrow site 9.002PA will be developed.

**Figure 5-119: Looking Southwest at Borrow Site 9.002B over Existing Little Smith Creek Airstrip**

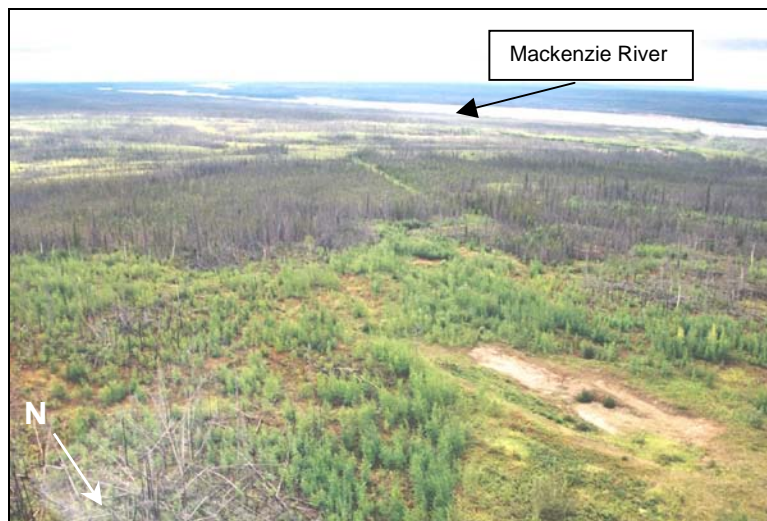
Borrow source 9.017 is located 500 m from the south bank of the Saline River, about 1,500 m upstream from the mouth of the Mackenzie River. The site is a broad, flat glaciofluvial plain that contains both level and hummocky terrain, as shown in [Figure 5-121](#). Overall, the source is about 2,400 m long (east to west) and about 1,600 m wide encompassing an area of about 384 ha. Borrow site 9.017P is about 500 m wide and 630 m long encompassing an area of about 31.6 ha. See [Figure 5-122](#) for an overview map of the borrow site. See [Figure 5-126](#) for a site-specific map of the borrow site.

**Figure 5-121: Borrow Source 9.017**

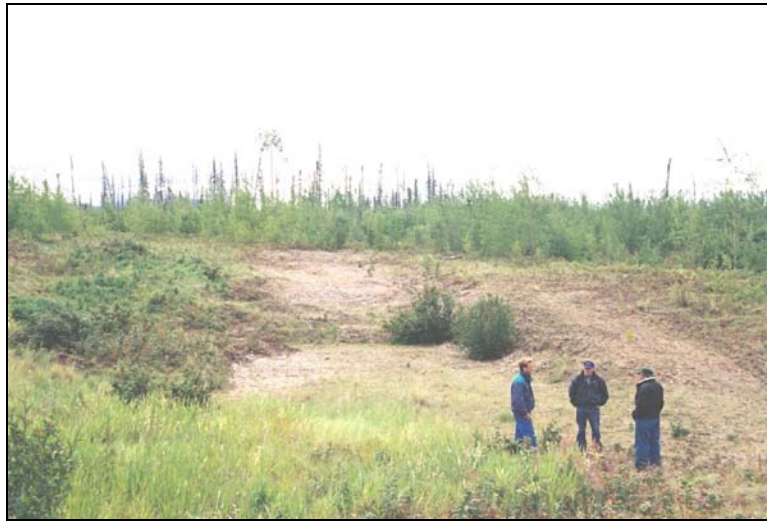
A small existing gravel pit is located within the site. A large area on the site has been previously cleared, and it appears that more gravelly material might have been high-graded from the pit, as shown in [Figure 5-123](#).

**Figure 5-123: Exposed Granular Material on Borrow Source 9.017  
(Direction Unknown)**

Available information suggests that the granular material in this site is primarily fine to coarse grained sand with a highly variable silt content. Scattered pockets or layers of medium grained gravel, with a little silt, were encountered at depths in excess of 4.5 m below the ground surface in some areas of the site. The sand from this site in the pit run condition is considered suitable for lower quality fill material in the construction of road subgrades, berms and utility backfill. Moisture content in the granular material is low to medium.

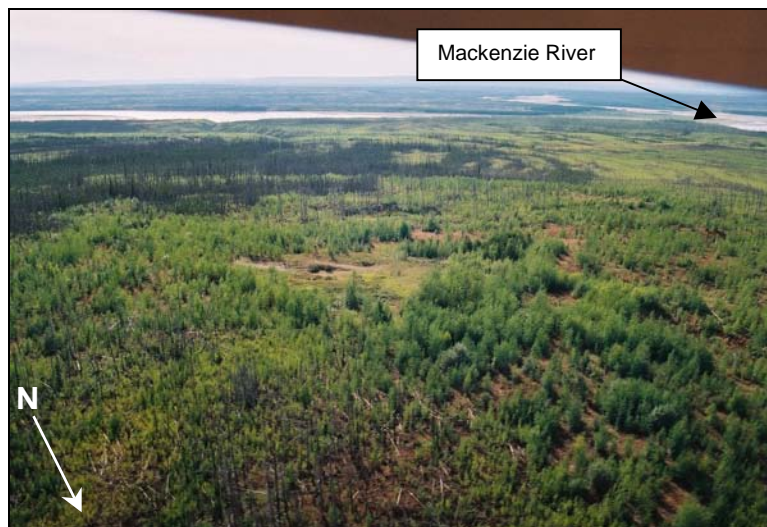
Hummocky glaciofluvial sediments are rapidly to moderately well drained and have typically developed soils of the Brunisolic Order. Limited drilling at the deposit suggests the borrow site is frozen. Ice contents are expected to be in the range of 5 to 20% by weight. The glaciolacustrine sediments are moderately well drained and have likely developed soils of the Brunisolic and Cryosolic Orders. The glaciolacustrine sediments are characterized by a blanket slope drainage pattern indicating that drainage might be in part controlled by the permafrost table. Permafrost areas in glaciolacustrine sediments commonly contain between 50 and 70% ice content by weight. Permafrost is expected in 30 to 50% of the glaciolacustrine area.

**Figure 5-124: Soils and Landforms Setting at Borrow Site 9.017P**

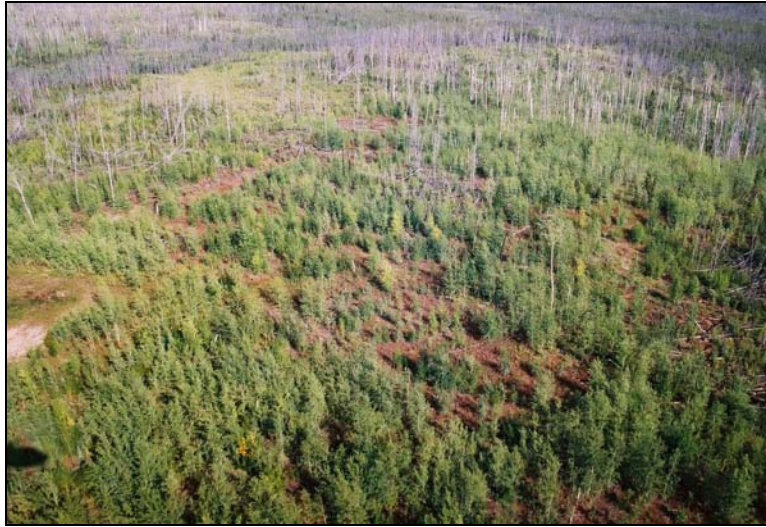
The burnt mixedwood vegetation type is located in upland forested areas, with jack pine, trembling aspen and white spruce regenerating into the tree canopy. Shrubs include green alder, prickly rose, soapberry, white spruce, trembling aspen and low-bush cranberry. Mountain cranberry, bunchberry, northern comandra, twinflower and fireweed compose the ground cover with stair-step moss and Schreber's moss dominating the forest floor.

Regenerating black spruce/Labrador tea/mountain cranberry vegetation is found in burned lowland areas with level topography. Black spruce is found in both the tree and the shrub layer. Labrador tea, willow, sweet gale, green alder and bog bilberry comprise the shrub layer along with Alaska birch, shrubby cinquefoil and prickly rose. The ground cover layer includes red bearberry and fireweed with an abundance of club lichens, pelt lichens and reindeer lichens.

**Figure 5-125: Example of Vegetation at Borrow Site 9.017P (Direction Unknown)**

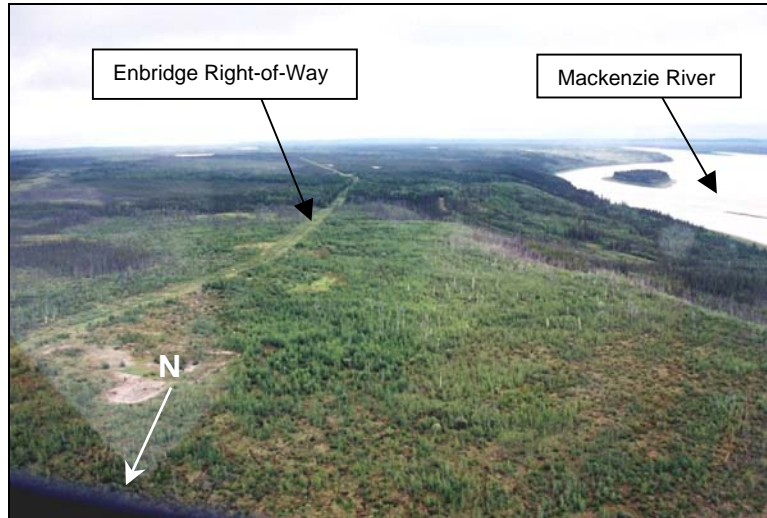
Borrow site 9.024AP is located on a glaciofluvial outwash terrace that is flat to sloping and is bounded on the north and west sides by steep banks. The site area is well drained and existing borehole information suggests that the deposit is unfrozen to depths of at least 4.5 m. The granular material consists of stratified silty sand and gravel. The southern portion of the site might contain material with finer sand and silt content. The terrace is free of overburden except for a thin mat of vegetation. The site is located within a large burn and is passed on its eastern edge by the Enbridge pipeline. Immediately south and east of the deposit is a glaciolacustrine plain containing silt and clay.

**Figure 5-128: Existing Pit on Borrow Source 9.024**

Test pit B6-1 penetrated about 0.3 m of silty sand, underlain by about 1.5 m of fine to coarse grained, well graded gravel with some silt. The soils encountered in test pit B6-1 were unfrozen with low moisture contents. Sieve analysis on material from the test pit contained about 67% gravel, about 30% sand, and about 3% silt.

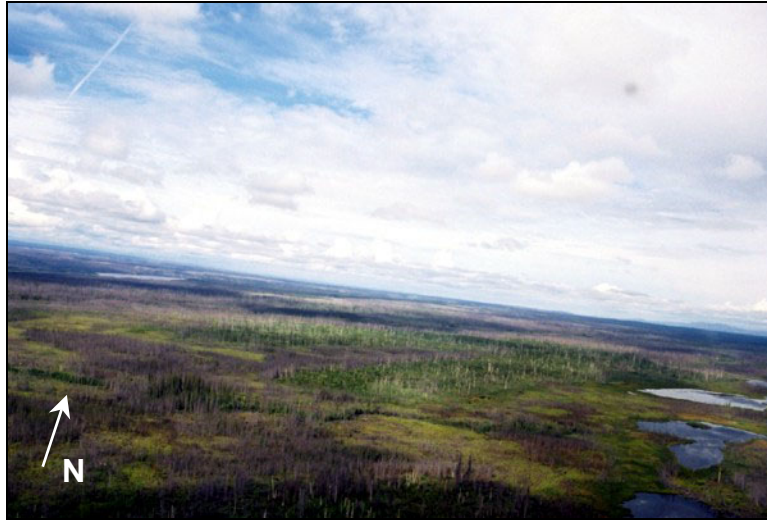
Borrow site 9.038PB is located on the northern portion of a north-south trending glaciofluvial plain that is a broad, low feature rising about 3.0 m to 4.0 m above the adjacent landscape. A small tributary stream crosses the northern tip of the glaciofluvial plain northeast of borrow site 9.038PB. The material in the site is expected to be fair quality stratified, well graded, sand and gravel. The terrain to the east of the borrow site is slightly depressional, exhibiting thermally sensitive features such as small ponds and muskeg bogs, as shown in [Figure 5-131](#). Drainage on the borrow site is fair to good with an organic topsoil layer that is relatively shallow.

**Figure 5-131: Small Ponds Bordering Borrow Site 9.038PB**

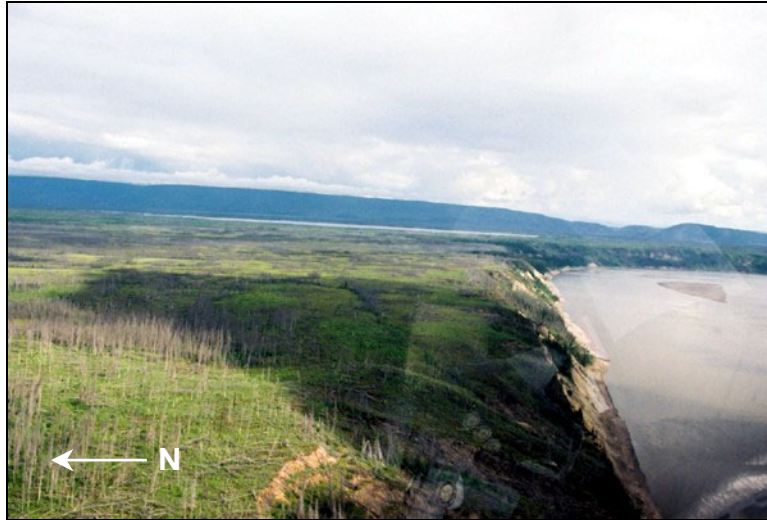
Borrow site 9.038PA is located in the southern portion of a north-south trending glaciofluvial plain that is a broad, low feature rising about 3.0 m to 4.0 m above the adjacent landscape. The southern perimeter of the borrow site consists of the steep Mackenzie River bank, as shown in [Figure 5-134](#). The material in the site is expected to be fair quality stratified, well graded, sand and gravel. The terrain to the east of the borrow site is slightly depressional, exhibiting thermally sensitive features such as small ponds and muskeg bogs. Drainage on the borrow site is fair to good with an organic topsoil layer that is relatively shallow.

**Figure 5-134: Looking East to Borrow Site 9.038PA on Mackenzie River Embankment**
